## **Rock fill dam and Irrigation channel constructed under NICRA improves the livelihood of Dhansiripar village of Dimapur in Nagaland**

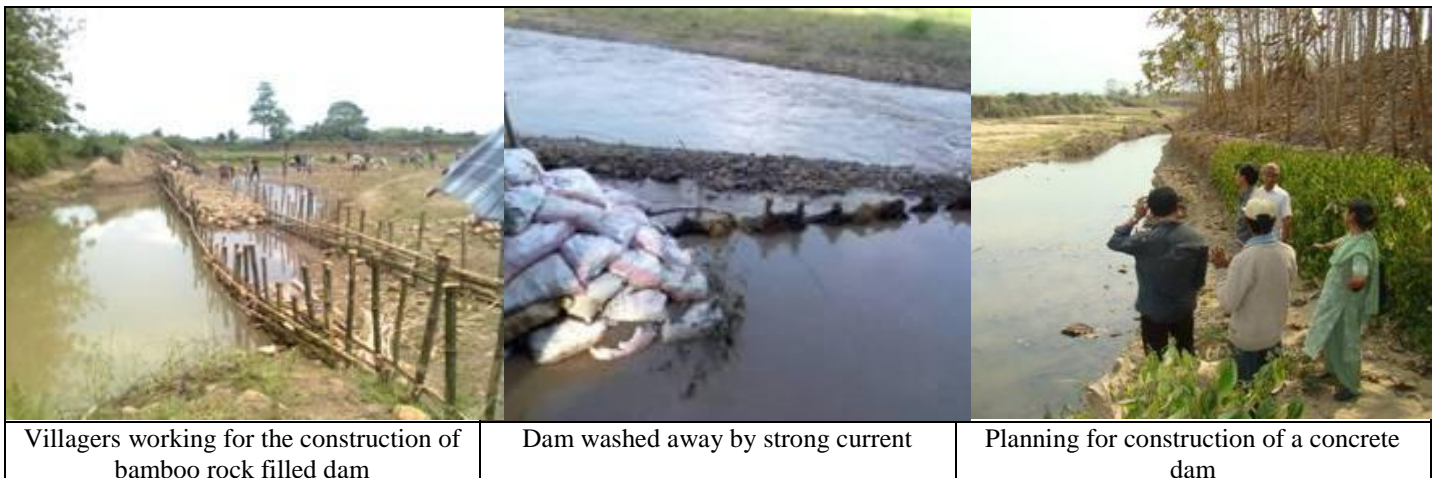
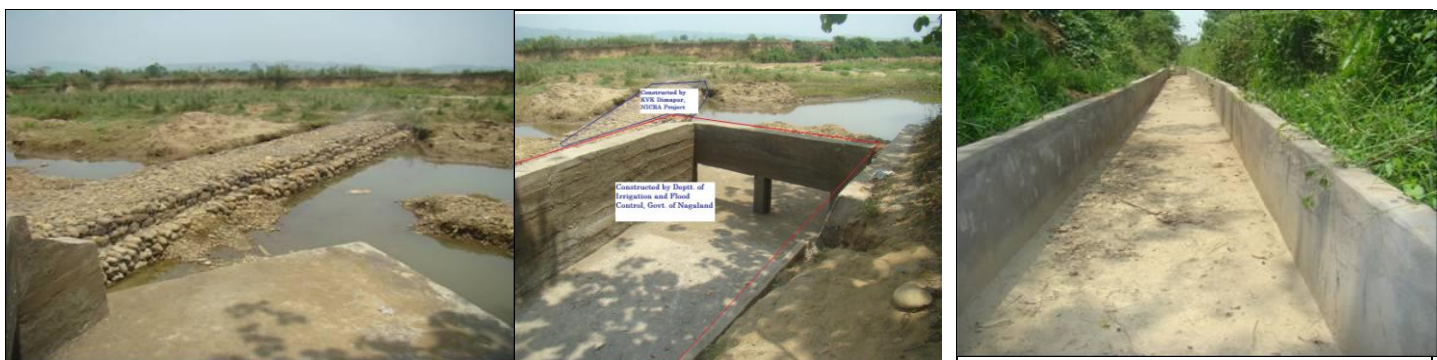
Dam constructed with Sausage wire & boulders

Concrete dam constructed

Irrigation channel of 1100 ft.

Considering the difficulties of the villagers, an initiative was taken to manage the natural resources for irrigation purpose under NICRA project during the year 2011-2012 and accordingly a rock fill dam using sausage wire and a concrete irrigation channel (1100 ft.) was constructed to irrigate the paddy crop. The command area under the irrigation channel is 150 hectares. During 2012-13, the average productivity of the paddy has gone up to 3.3 t/ ha. 50 hectares of paddy fallow land was also utilized to grow rape seed & mustard as second crop after paddy, which never happened prior to this initiative of ICAR Complex, Nagaland centre.

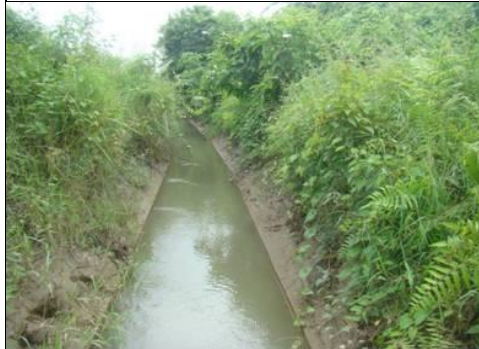
Water from the dam flowing towards the field

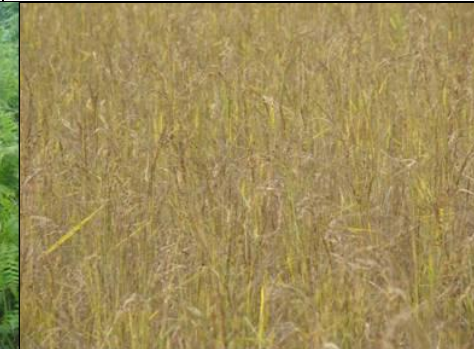
Moisture stress during flowering & grain filling stage during 2011

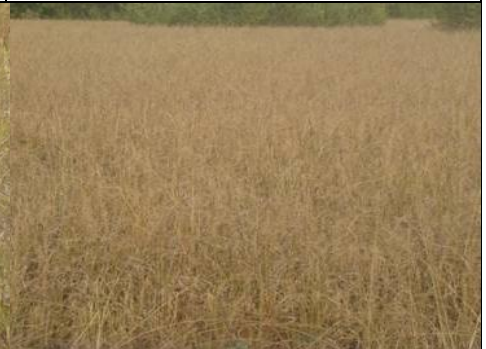
114.29 ha of land under paddy cultivation under moisture stress

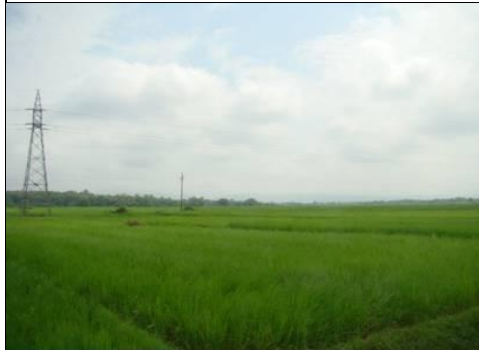
125.40 ha of land brought under lowland paddy after construction of dam in 2012

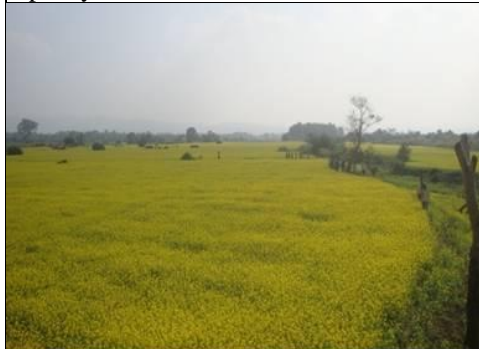
50 ha area covered under toria as second crop after harvest of paddy along the irrigation channel
