## Participatory Water Resource Development Making a Difference

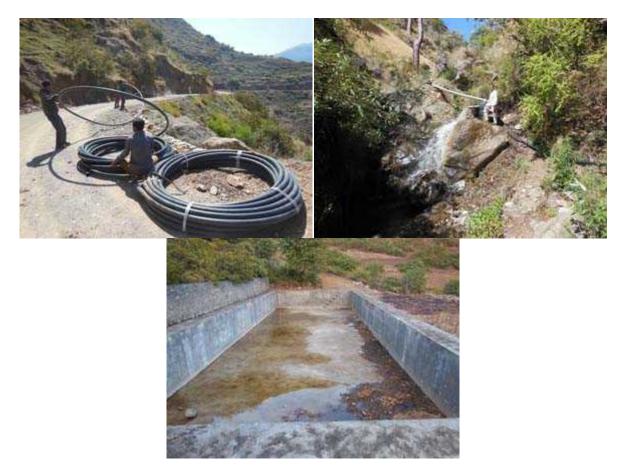
elevation difference and shortage of electricity power for running the system. As a part of last intervention, a masonry tank of about 280 m3 storage capacity was constructed for storing the water at elevated place but it also proved non-functional.

After conducting detailed field survey and interaction with the farmers, water resource development initiatives were taken up in Attal village through laying a HDPE pipe line of 6.0 km length in a very difficult hilly terrain to harvest the water from a perennial source. The source had sufficient discharge available (about 15 lps) and was connected to the previous non-functional water tank. On monitoring, it was found that huge seepage loss of stored water (3 cm per hour at 1.25 m stage or about 1.45 lps) is occurring due to minor cracks developed in the tank. These seepage losses were arrested by lining the tank with silpaulin sheet of 250 gsm. In these interventions, villagers had contributed in terms of labour required for digging of trench and burying of pipe for entire length of 6.0 km. This intervention was taken up in a participatory mode with a total cost of Rs. 7,20,000/-, in which about 21 percent (Rs. 1,50,000/-) was contributed by the farmers towards cost of digging trench, manual labour required for transportation of pipes, laying the pipe line and cleaning of tank and fixing of silpaulin sheet in the tank.
